Technical Memorandum

To: Marc Culver, P.E., City of Maple Grove
From: Mike Spack, P.E., P.T.O.E.
Date: August 9, 2011
Re: Effects on Pedestrian Safety of Upgrading the Pedestrian Crossing at Elm Creek Boulevard/90th Place in Maple Grove, MN

The pedestrian crossing signs on Elm Creek Boulevard at 90th Place near Kerber Park in Maple Grove, MN were recently upgraded in an effort to improve pedestrian safety. This memorandum documents the vehicle-pedestrian interactions at the site and reviews the effects of the signage change.

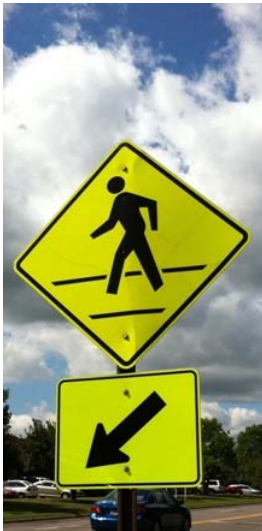
Figure 1 – Crosswalk Sign (before)

The existing W11-2 fluorescent yellow/green pedestrian signs were replaced with lit, push-button activated pedestrian crossing signs in June, 2011. Figure 1 depicts the style of sign originally on-site and Figure 2 depicts the style of the new pedestrian crossing sign. It is believed the upgraded pedestrian signal will enhance pedestrian safety, but a literature review did not provide any before/after studies that proved the effectiveness of the LED lit sign. This study documents the yielding behavior of vehicles to pedestrians “before” and “after” the LED, push button activated pedestrian crossing signs were installed.

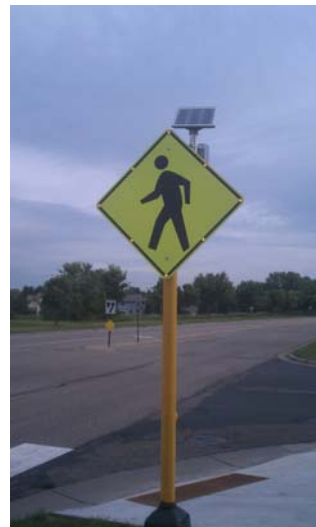
Figure 2 – Crosswalk Sign with Lights (after)

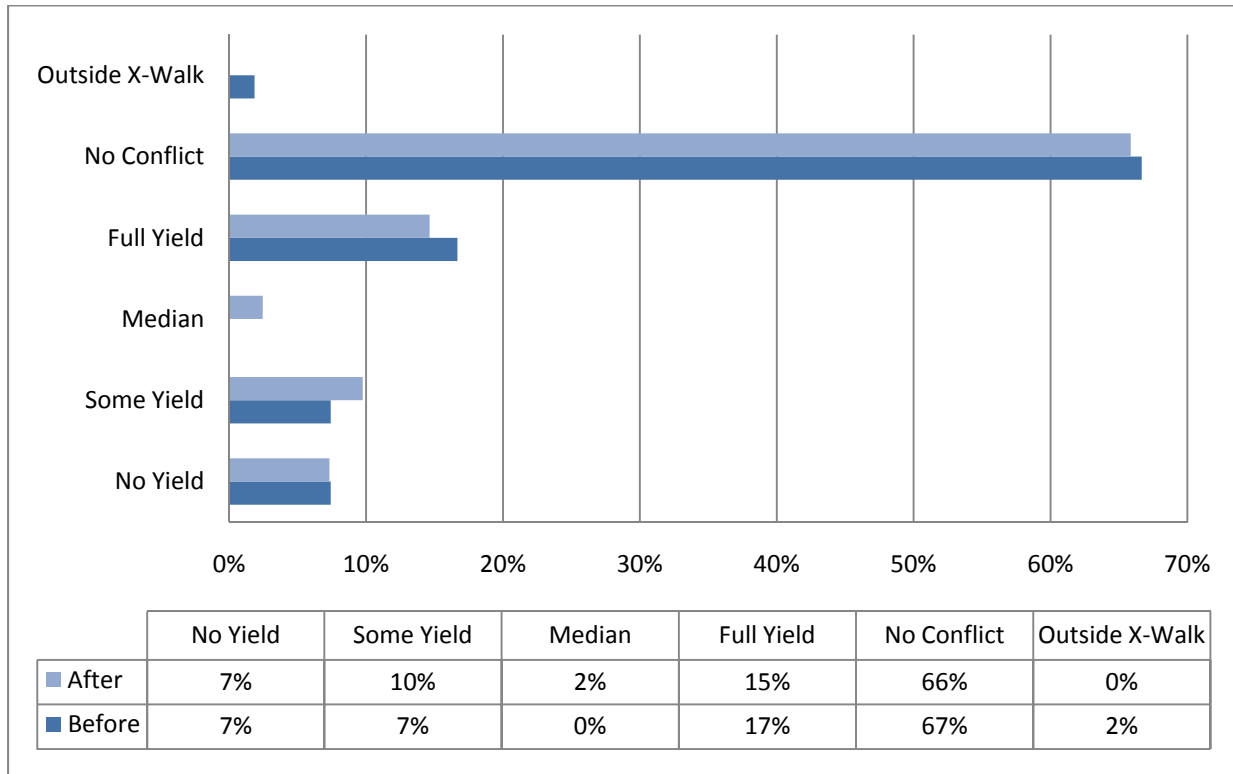
Figure 3 – Percentage of Total for Each Interaction

Due to the differing sample sizes, the vehicle-pedestrian interaction numbers were not compared directly. Instead, the sample sizes were used to calculate percentages for each interaction type before and after the upgrades were employed. Figure 3 summarizes the percentages by interaction for the before and after conditions.

As can be seen in Figure 3, the percentages for each interaction type before and after the signs were installed closely resemble each other. The upgraded signs do not appear to have a particular effect on vehicles yielding to pedestrians. Unfortunately, less than 20% of the pedestrians pushed the LED activation button in the study period after the LED signs were installed. Greater use of the push-buttons (or installing automated pedestrian detection) may improve the vehicle yielding behavior.
